Test Report No: WTH1901#1-1

Testing of: Side hung next to top hung flush casement window

Tested to: PAS 24 : 2016

Prepared for: Nico Manufacturing Ltd

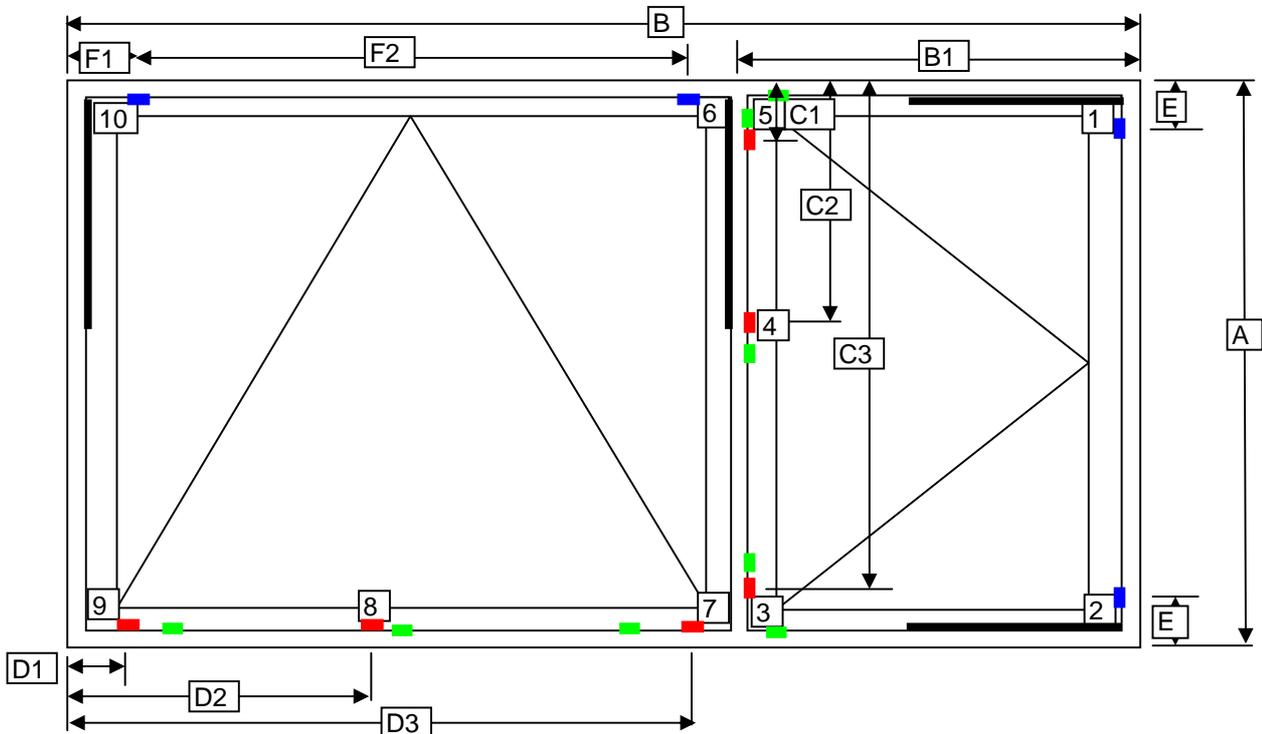
TEST WINDOW DRAWING

- Run up block
- Locking points
- Hinge protectors

A	=	1500	mm
B	=	1950	mm
B1	=	750	mm
C1	=		mm
C2	=		mm
C3	=		mm
D1	=		mm
D2	=		mm
D3	=		mm
E	=		mm
F1	=		mm
F2	=		mm

Sample No	WTH1901F	Temperature	20°C	Humidity	44%RH	Date	09/04/2019
Load location	Parallel to plain load	Perpendicular to plain load	Observations / Assessment				
1 Top hinge & hinge protector, S/H sash Vertically down	1000 N (10 sec)	3000 N (10 sec)	Held for 10 seconds				
1 Top hinge & hinge protector, S/H sash Horiz	1000 N (10 sec)	3000 N (10 sec)	Held for 10 seconds				
2 Top opening corner & top lock point S/H sash Vertically down	1000 N (10 sec)	3000 N (10 sec)	Held for 10 seconds				
2 Top opening corner & top lock point S/H sash Horizontal + mullion pull	1000 N (10 sec)	3000 N (10 sec)	Held for 10 seconds				
3 Centre lock point S/H sash Vertically down	1000 N (10 sec)	3000 N (10 sec)	Held for 10 seconds				
3 Centre lock point S/H sash Horizontal + mullion pull	1000 N (10 sec)	3000 N (10 sec)	Held for 10 seconds				
4 Bottom opening corner & bottom lock point S/H sash Vertically up	1000 N (10 sec)	3000 N (10 sec)	Held for 10 seconds

4 Bottom opening corner & bottom lock point S/H sash Horizontal + mullion pull	1000 N (10 sec)	3000 N (10 sec)	Held for 10 seconds				
5 Bottom hinge & hinge protector, S/H sash Vertically up	1000 N (10 sec)	3000 N (10 sec)	Held for 10 seconds				
5 Bottom hinge & hinge protector, S/H sash Horizontal	1000 N (10 sec)	3000 N (10 sec)	Held for 10 seconds				
6 L/H hinge & hinge protector T/H sash Horizontal	1000 N (10 sec)	3000 N (10 sec)	Held for 10 seconds

Sample No	WTH1901F	Temperature	20°C	Humidity	44%RH	Date	09/04/2019
Load location	Parallel to plain load	Perpendicular to plain load	Observations / Assessment				
6 L/H hinge & hinge protector T/H sash Vertically down	1000 N (10 sec)	3000 N (10 sec)	Held for 10 seconds				
7 L/H opening corner & lock point T/H sash Horizontal	1000 N (10 sec)	3000 N (10 sec)	Held for 10 seconds				
7 L/H opening corner & lock point T/H sash Vertically up	1000 N (10 sec)	3000 N (10 sec)	Held for 10 seconds				
8 Centre lock point T/H sash Horizontal	1000 N (10 sec)	3000 N (10 sec)	Held for 10 seconds				
8 Centre lock point T/H sash Vertically up	1000 N (10 sec)	3000 N (10 sec)	Held for 10 seconds				
9 R/H opening corner & lock point T/H sash Horizontal	1000 N (10 sec)	3000 N (10 sec)	Held for 10 seconds				
9 R/H opening corner & lock point T/H sash Vertically up	1000 N (10 sec)	3000 N (10 sec)	Held for 10 seconds

10 R/H hinge & hinge protector T/H sash Horizontal + mullion pull	1000 N (10 sec)	3000 N (10 sec)	Held for 10 seconds				
10 R/H hinge & hinge protector T/H sash Vertically down	1000 N (10 sec)	3000 N (10 sec)	Held for 10 seconds				
	1000 N (10 sec)	3000 N (10 sec)					
	1000 N (10 sec)	3000 N (10 sec)
